**Flood Control Project Maintenance
Levee Inspections**

Fall 2009 Levee Maintenance Deficiency Summary Report

Reclamation District No. 0999

Levee Inspection Report By Mile - Fall 2009

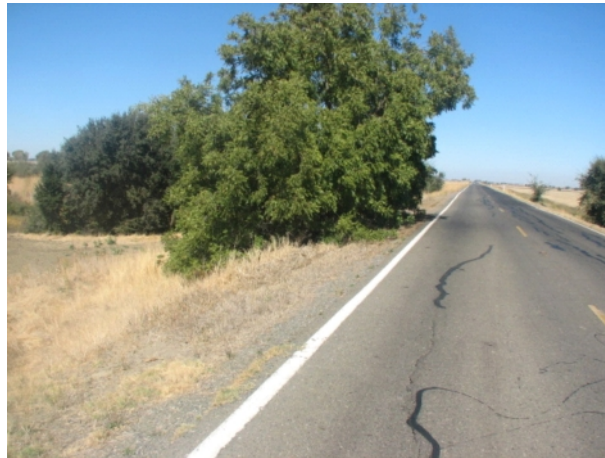
Levee Mile Report Line	1
Start Levee Mile	1.75
End Levee Mile	1.77
Location	Water Side
Category	Earthen Levee
Item	Trim / Thin Trees

Looking east at overgrown trees on waterside slope and shoulder

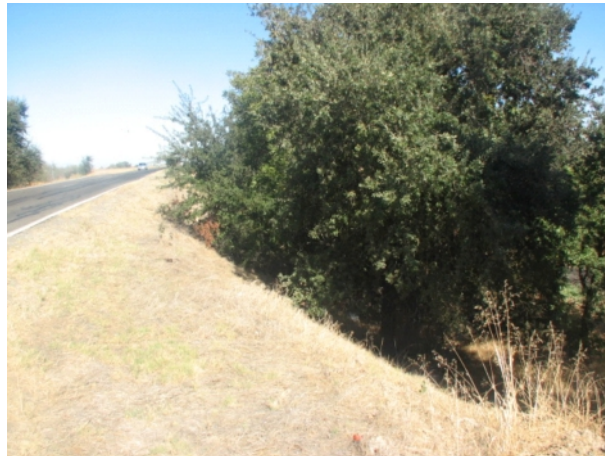
Levee Mile Report Line	1
Start Levee Mile	1.75
End Levee Mile	1.77
Location	Water Side
Category	Earthen Levee
Item	Trim / Thin Trees

Looking west at overgrown trees on waterside slope and toe.

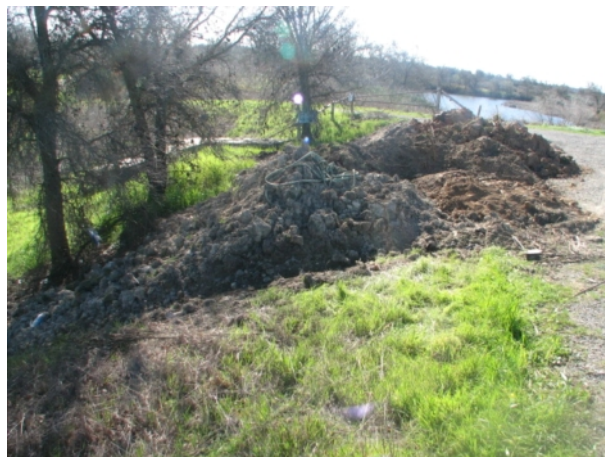
Levee Mile Report Line	2
Start Levee Mile	1.78
End Levee Mile	1.78
Location	Land Side
Category	Earthen Levee
Item	Encroachments

Material pile on landside shoulder at LM 1.78

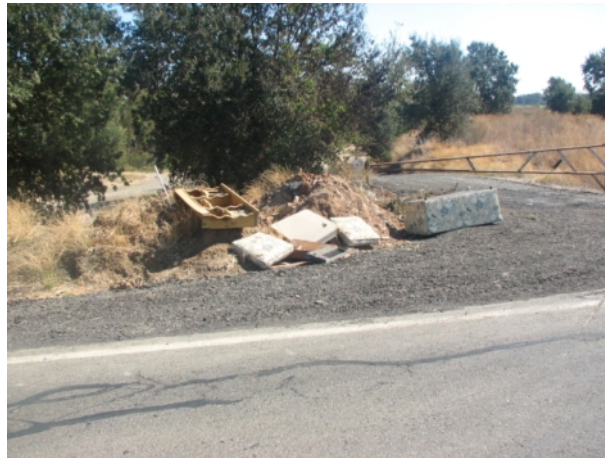
Levee Mile Report Line	2
Start Levee Mile	1.78
End Levee Mile	1.78
Location	Land Side
Category	Earthen Levee
Item	Encroachments

Looking north at garbage pile on landside shoulder.

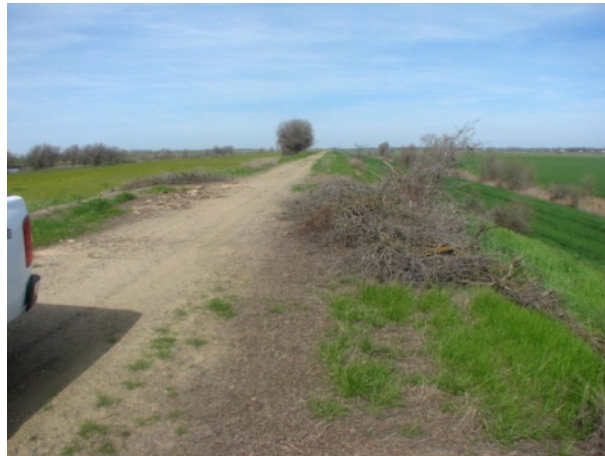
Levee Mile Report Line	11
Start Levee Mile	4.15
End Levee Mile	4.21
Location	Water Side
Category	Earthen Levee
Item	Encroachments

Pruning pile on waterside shoulder.

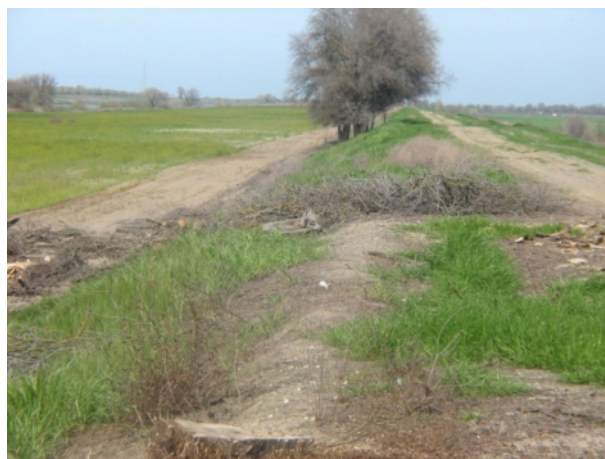
Levee Mile Report Line	12
Start Levee Mile	4.17
End Levee Mile	4.18
Location	Land Side
Category	Earthen Levee
Item	Encroachments

Prunings on waterside shoulder, slope & toe.

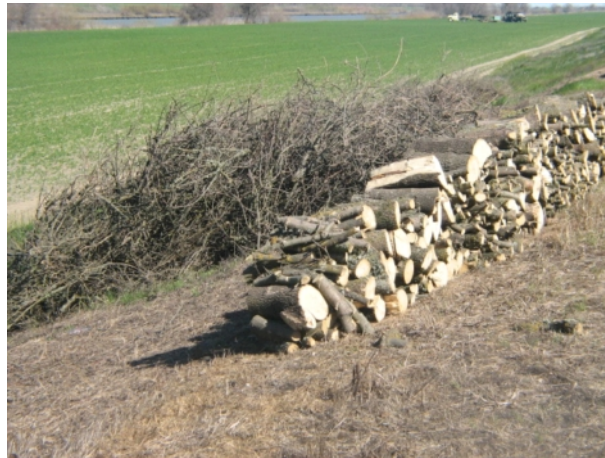
Levee Mile Report Line	14
Start Levee Mile	4.57
End Levee Mile	4.61
Location	Water Side
Category	Earthen Levee
Item	Encroachments

Pruning & Firewood pile along waterside shoulder and slope at LM 1.56

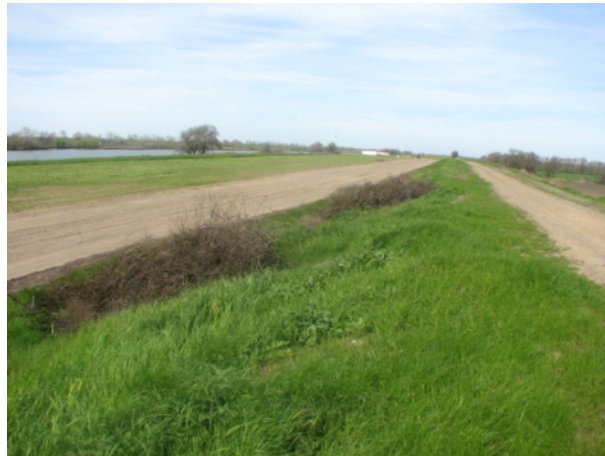
Levee Mile Report Line	14
Start Levee Mile	4.57
End Levee Mile	4.61
Location	Water Side
Category	Earthen Levee
Item	Encroachments

Prunings on waterside slope.

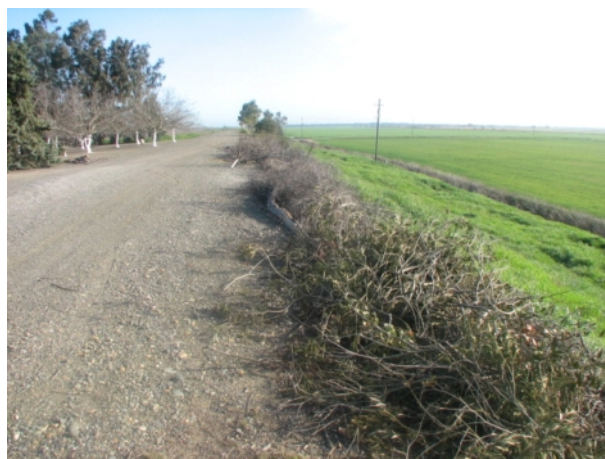
Levee Mile Report Line	18
Start Levee Mile	6.55
End Levee Mile	6.60
Location	Land Side
Category	Earthen Levee
Item	Encroachments

Prunings along landside shoulder.

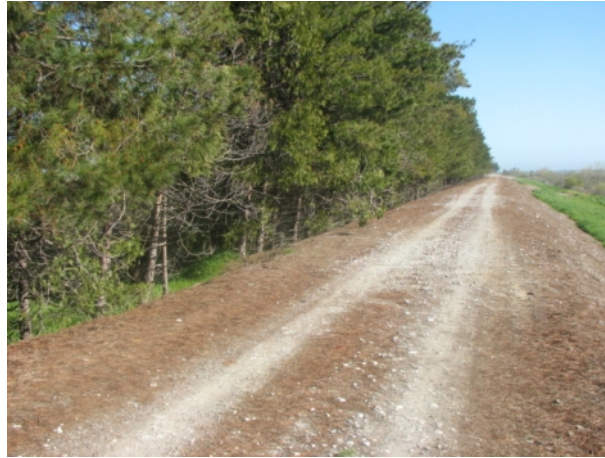
Levee Mile Report Line	25
Start Levee Mile	10.83
End Levee Mile	11.07
Location	Water Side
Category	Earthen Levee
Item	Trim / Thin Trees
Pine trees along waterside shoulder & slope. (Site of a old christmas tree farm).	
richard_20091001_23.jpg

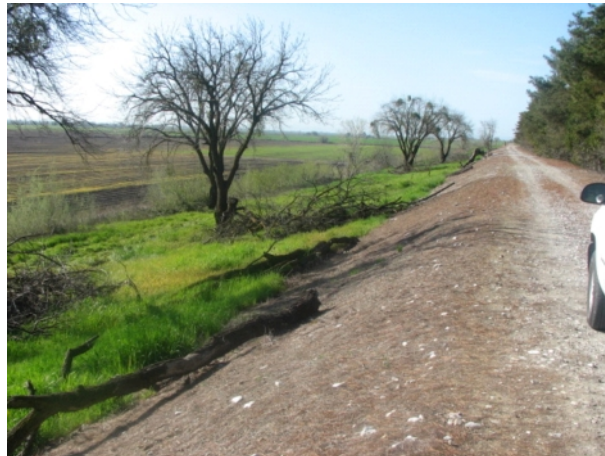
Levee Mile Report Line	26
Start Levee Mile	10.87
End Levee Mile	11.23
Location	Land Side
Category	Earthen Levee
Item	Encroachments
Tree limbs along landside slope & toe.	
richard_20091001_24.jpg

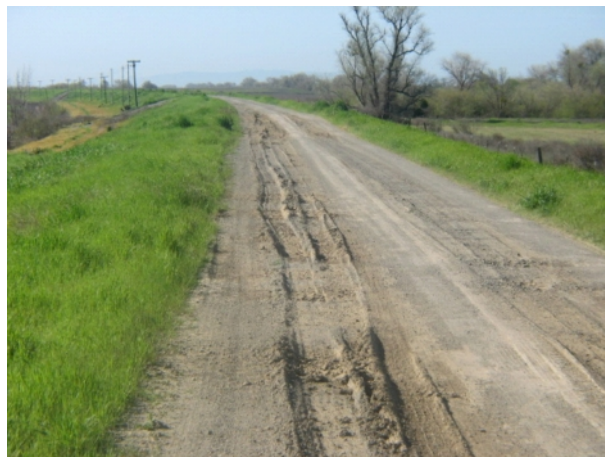
Levee Mile Report Line	27
Start Levee Mile	11.91
End Levee Mile	12.23
Location	Crown
Category	Earthen Levee
Item	Crown Surface / Depressions / Rutting
Vehicle ruts along crown road way.	
richard_20091001_27.jpg

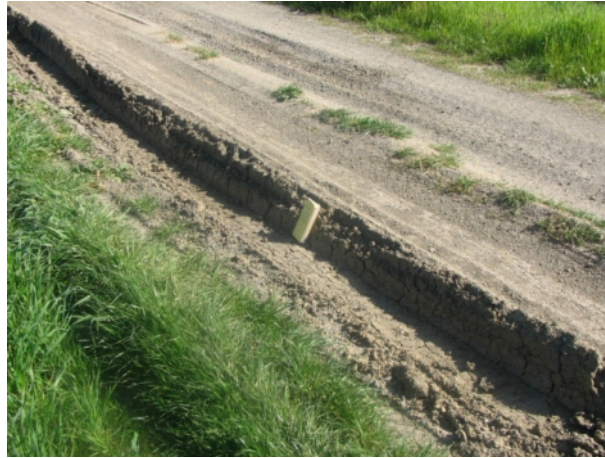
Levee Mile Report Line	29
Start Levee Mile	13.06
End Levee Mile	13.60
Location	Crown
Category	Earthen Levee
Item	Crown Surface / Depressions / Rutting
Deep (7" deep) rutting along crown roadway.	
richard_20091001_28.jpg

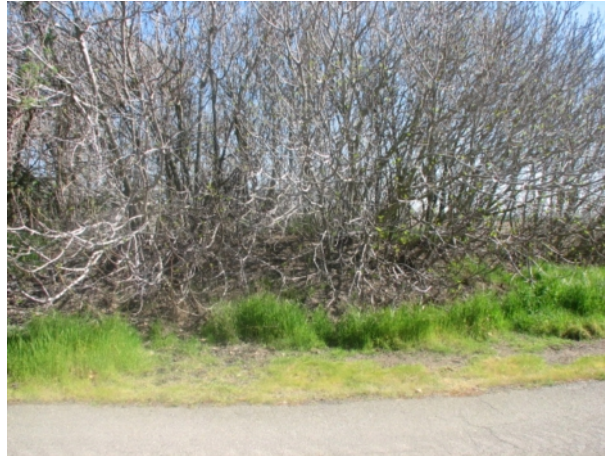
Front view of overgrown fig tree on landside shoulder.

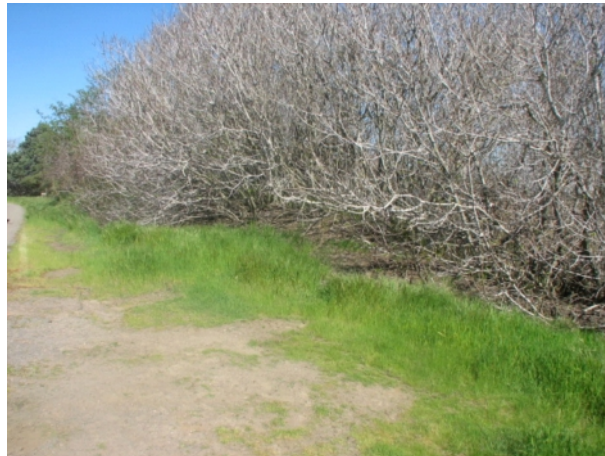
Levee Mile Report Line	11
Start Levee Mile	1.73
End Levee Mile	1.73
Location	Land Side
Category	Earthen Levee
Item	Trim / Thin Trees

Side view of overgrown fig tree along landside shoulder.

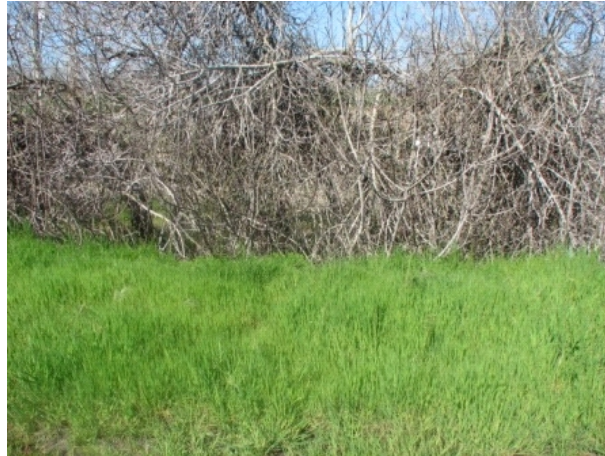
Levee Mile Report Line	1
Start Levee Mile	0.03
End Levee Mile	0.04
Location	Land Side
Category	Earthen Levee
Item	Trim / Thin Trees
Front view of overgrown trees on landside slope and toe.	
richard_20091001_61.jpg

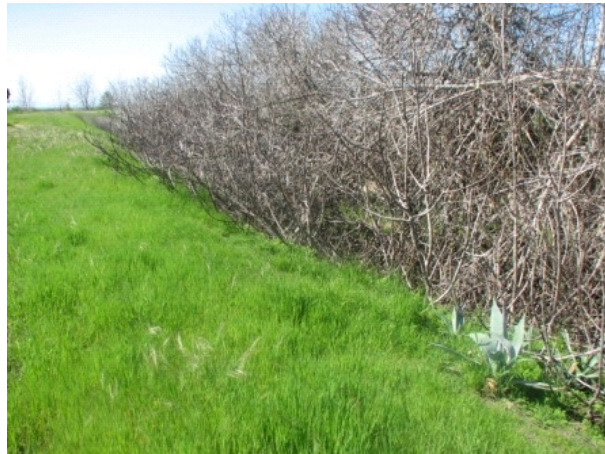
Levee Mile Report Line	1
Start Levee Mile	0.03
End Levee Mile	0.04
Location	Land Side
Category	Earthen Levee
Item	Trim / Thin Trees
Side view of overgrown trees on landside slope and toe.	
richard_20091001_62.jpg

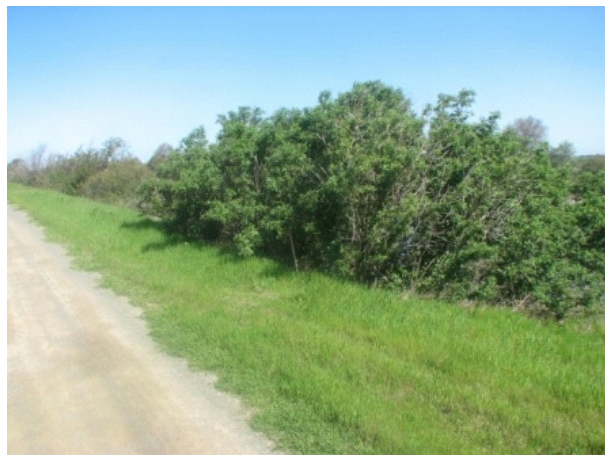
Levee Mile Report Line	4
Start Levee Mile	0.44
End Levee Mile	0.44
Location	Water Side
Category	Earthen Levee
Item	Vegetation
Elderberries blocking view of waterside slope.	
richard_20091001_63.jpg

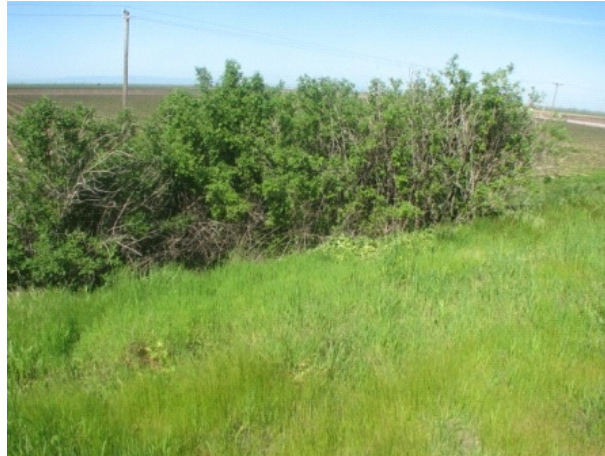
Elderberries blocking view of landside toe.

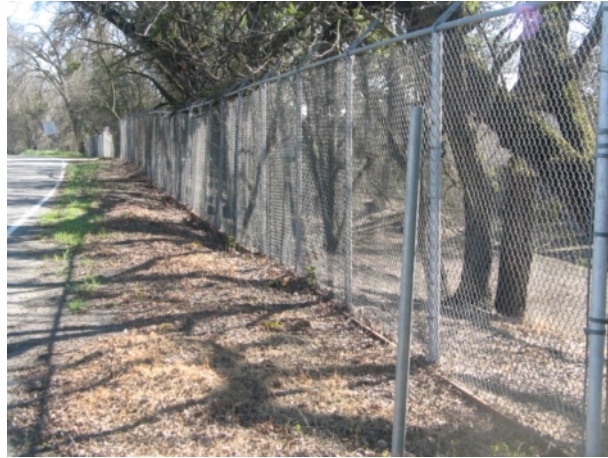
Levee Mile Report Line	3
Start Levee Mile	0.05
End Levee Mile	0.11
Location	Land Side
Category	Earthen Levee
Item	Encroachments
Cyclone fence along landside shoulder at LM 0.05 -0.11	
richard_20091001_37.jpg

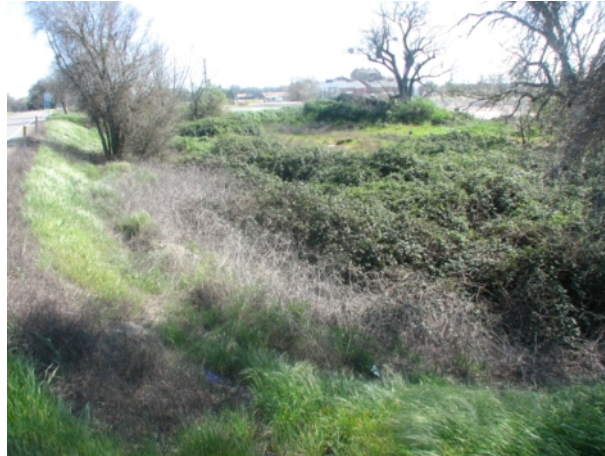
Dense wild roses at landside toe (side view)

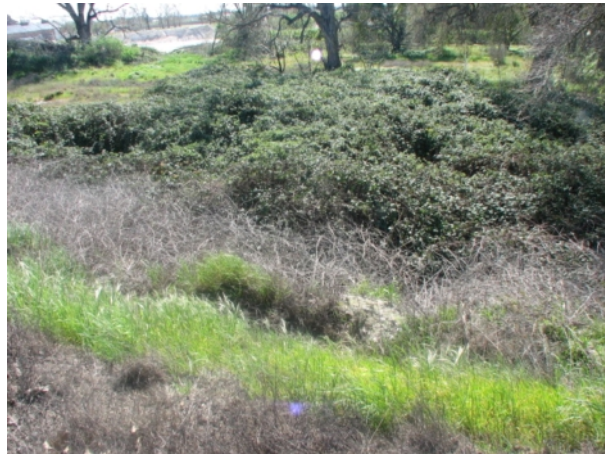
Levee Mile Report Line	1
Start Levee Mile	0.19
End Levee Mile	0.22
Location	Water Side
Category	Earthen Levee
Item	Trim / Thin Trees

Front view of dense wild roses at landside toe.

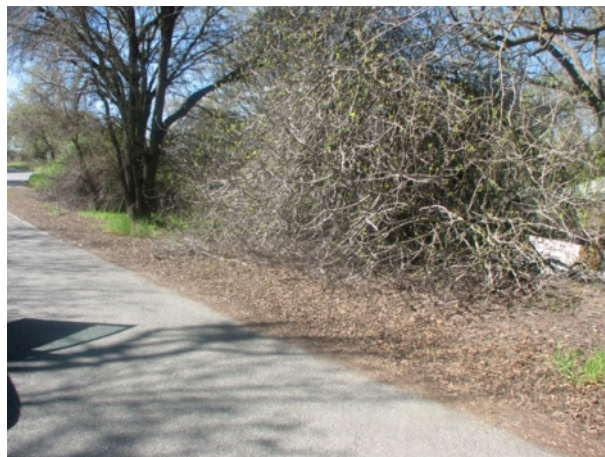
Levee Mile Report Line	6
Start Levee Mile	0.72
End Levee Mile	0.74
Location	Land Side
Category	Earthen Levee
Item	Trim / Thin Trees

Front view of dense trees at landside shoulder.

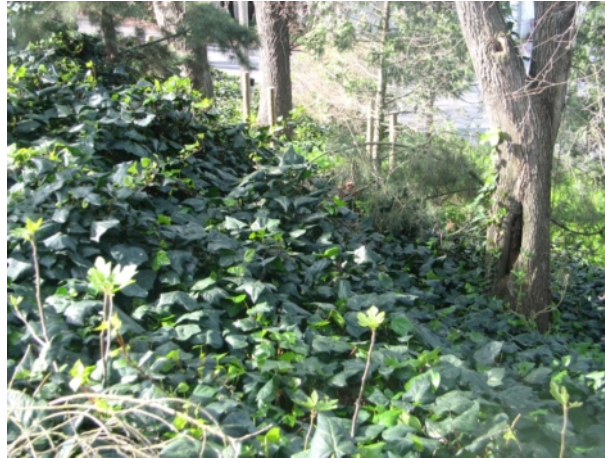
Levee Mile Report Line	8
Start Levee Mile	0.84
End Levee Mile	0.94
Location	Land Side
Category	Earthen Levee
Item	Encroachments
View of landscaping (Ivy) blocking view of landside slope from LM 0.84 to 0.94	
richard_20091216_146.jpg

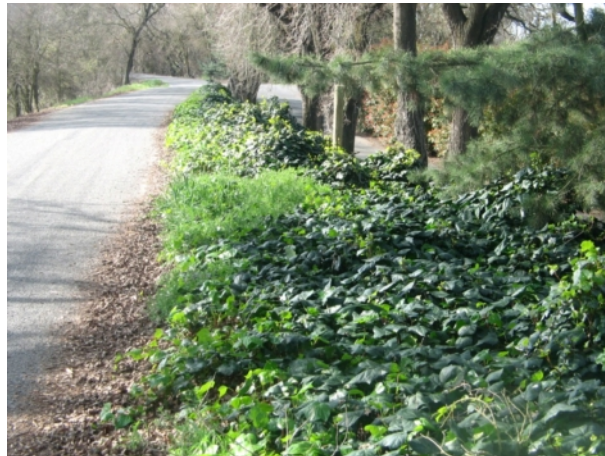
Levee Mile Report Line	8
Start Levee Mile	0.84
End Levee Mile	0.94
Location	Land Side
Category	Earthen Levee
Item	Encroachments
View of landscaping (Ivy) looking upstream from LM 0.84 to 0.94	
richard_20091216_147.jpg

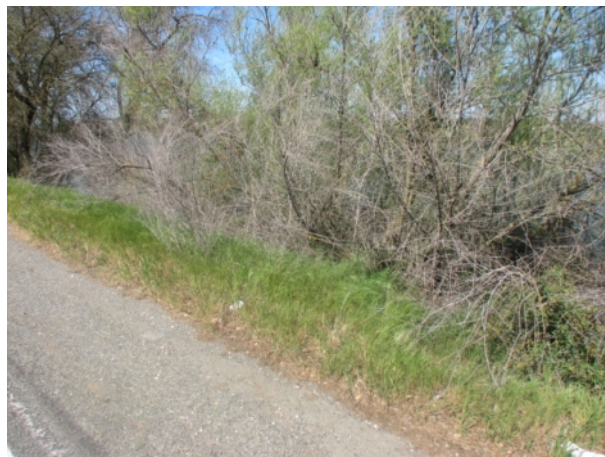
Levee Mile Report Line	14
Start Levee Mile	1.51
End Levee Mile	1.88
Location	Land Side
Category	Earthen Levee
Item	Trim / Thin Trees
Front view of dense trees along waterside slope.	
richard_20091216_148.jpg

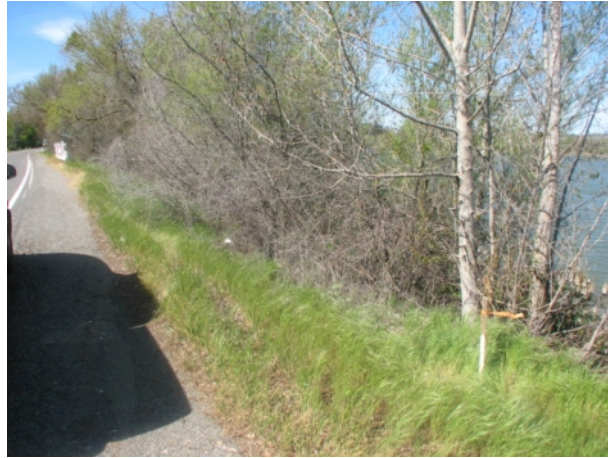
Side view of dense trees along waterside slope.

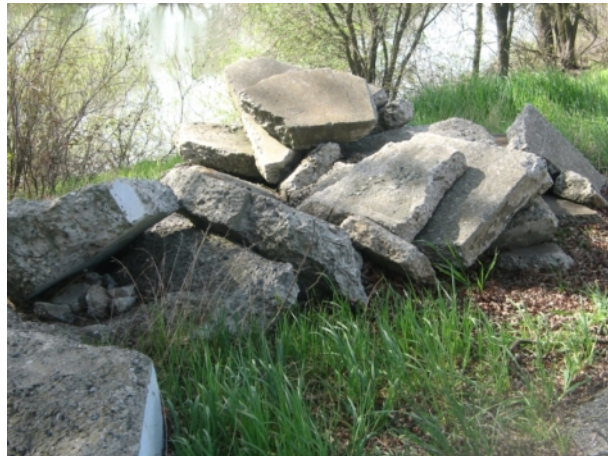
Levee Mile Report Line	20
Start Levee Mile	1.97
End Levee Mile	1.97
Location	Water Side
Category	Earthen Levee
Item	Encroachments

Concrete rubble on waterside sholder at LM 1.97

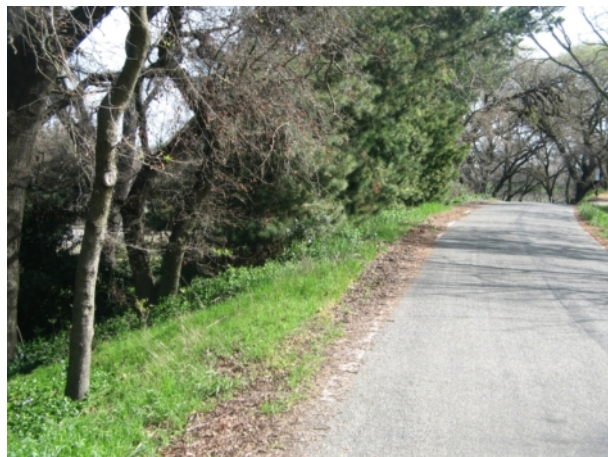
Levee Mile Report Line	27
Start Levee Mile	3.19
End Levee Mile	3.24
Location	Land Side
Category	Earthen Levee
Item	Encroachments

Looking downstream of landscaping blocking view of landside slope from LM 3.19 to 3.24

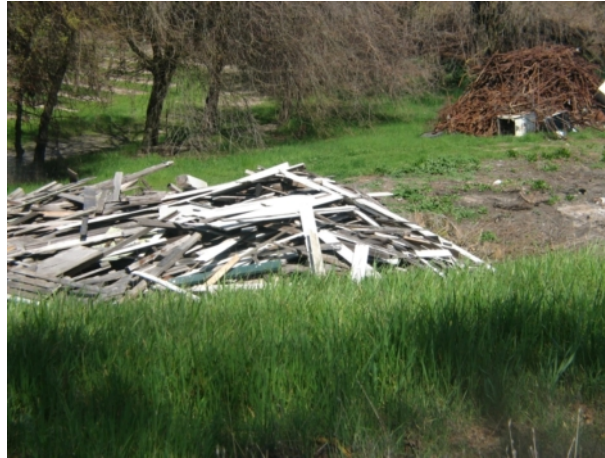
Garbage piles on landside toe at LM 3.96

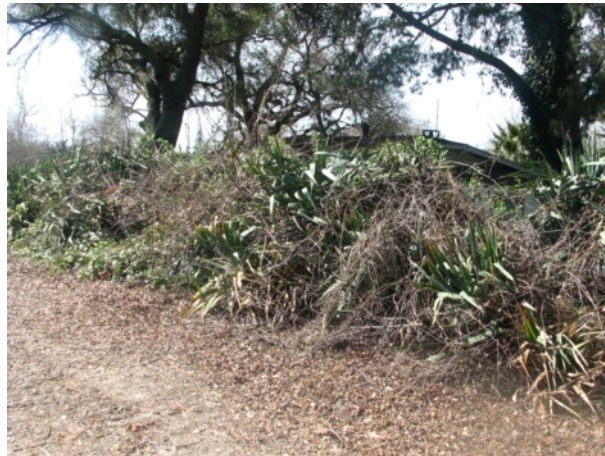
Levee Mile Report Line	41
Start Levee Mile	4.38
End Levee Mile	4.41
Location	Land Side
Category	Earthen Levee
Item	Encroachments

Overgrown landscaping on landside slope blocking view of slope from LM 4.38 to 4.41

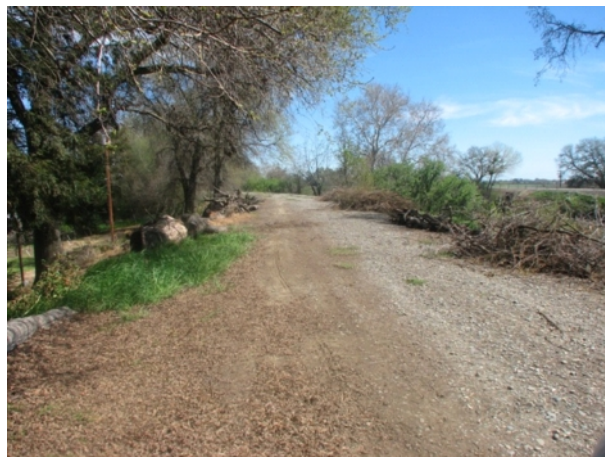
Levee Mile Report Line	47
Start Levee Mile	4.71
End Levee Mile	4.74
Location	Water Side
Category	Earthen Levee
Item	Encroachments

Pruning and firewood along landside and waterside shoulder.

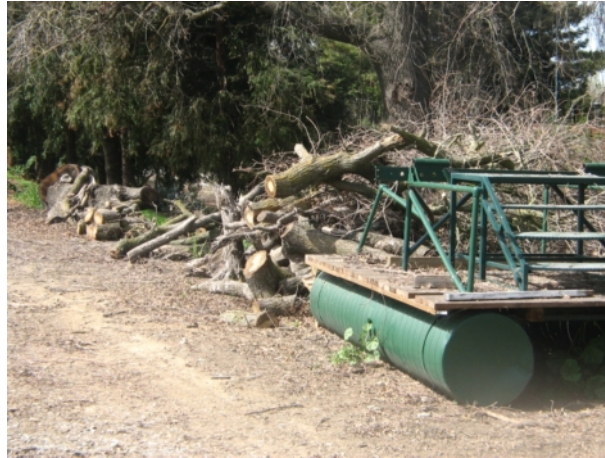
Prunings and firewood on landside shoulder at LM 4.72

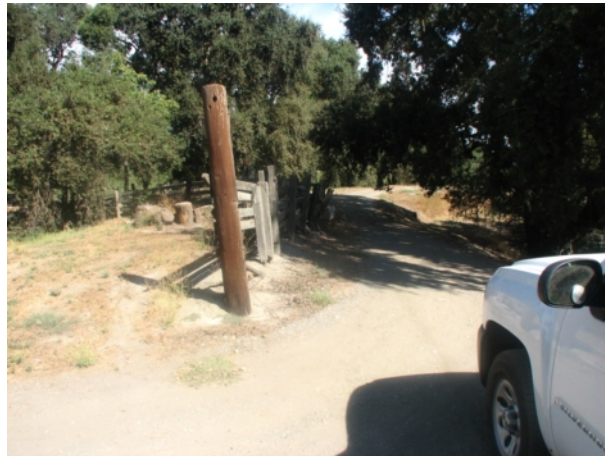
Levee Mile Report Line	58
Start Levee Mile	6.83
End Levee Mile	6.83
Location	Land Side
Category	Earthen Levee
Item	Encroachments

Fence and Firework at landside shoulder.

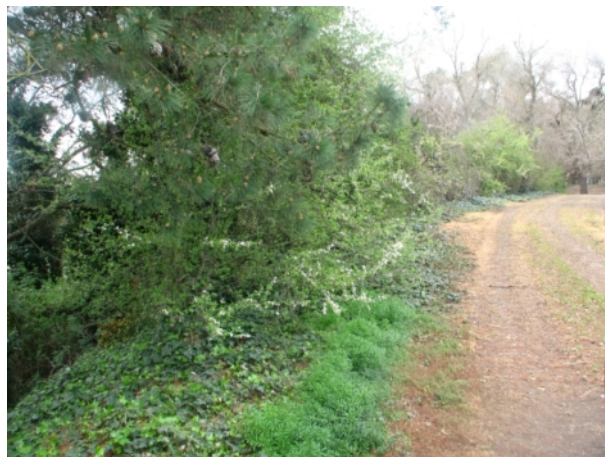
Levee Mile Report Line	61
Start Levee Mile	7.65
End Levee Mile	7.69
Location	Land Side
Category	Earthen Levee
Item	Encroachments

Landscaping on landside slope blocking view of slope from LM 7.65 to 7.72

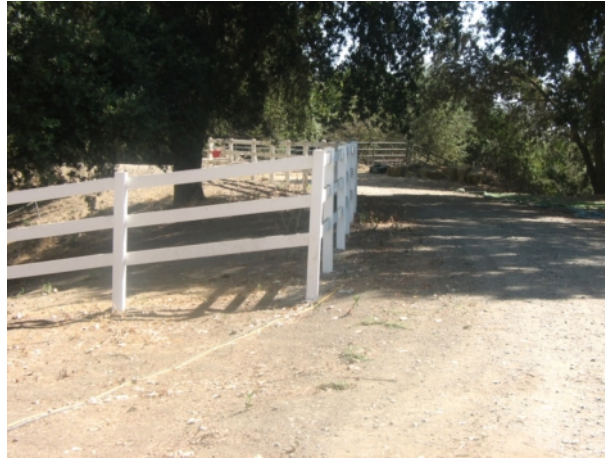
Levee Mile Report Line	66
Start Levee Mile	8.57
End Levee Mile	8.61
Location	Land Side
Category	Earthen Levee
Item	Encroachments
New installed unauthorized fence at landside slope and shoulder.	
richard_20091216_160.jpg

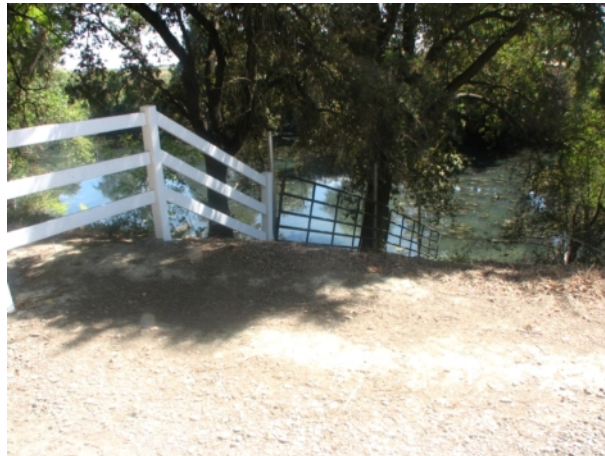
Levee Mile Report Line	68
Start Levee Mile	8.72
End Levee Mile	8.72
Location	Crown
Category	Earthen Levee
Item	Encroachments
New unauthorized fence that extend from landside toe to waterside toe.	
richard_20091216_161.jpg

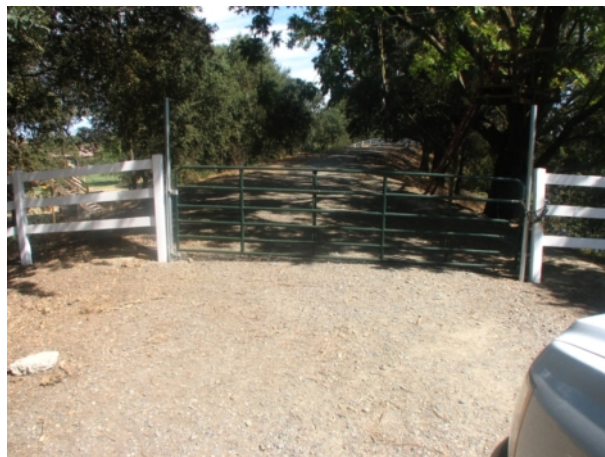
Levee Mile Report Line	68
Start Levee Mile	8.72
End Levee Mile	8.72
Location	Crown
Category	Earthen Levee
Item	Encroachments
View of fence & gate across levee crown, landside & waterside slope.	
richard_20091216_162.jpg

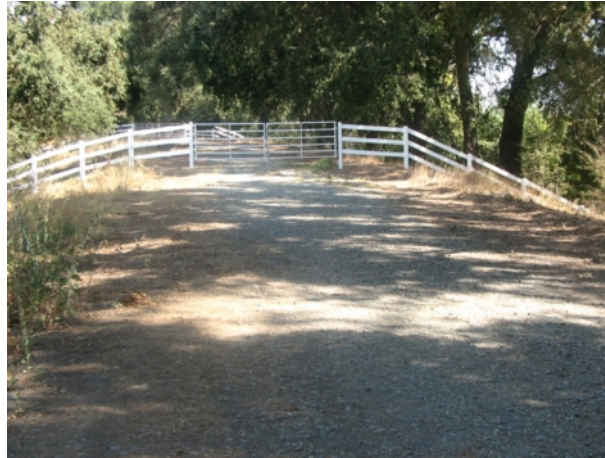
Levee Mile Report Line	69
Start Levee Mile	8.78
End Levee Mile	8.78
Location	Crown
Category	Earthen Levee
Item	Encroachments
New unauthorized fence and gate that extend from landside toe across levee crown to waterside toe.	
richard_20091216_163.jpg

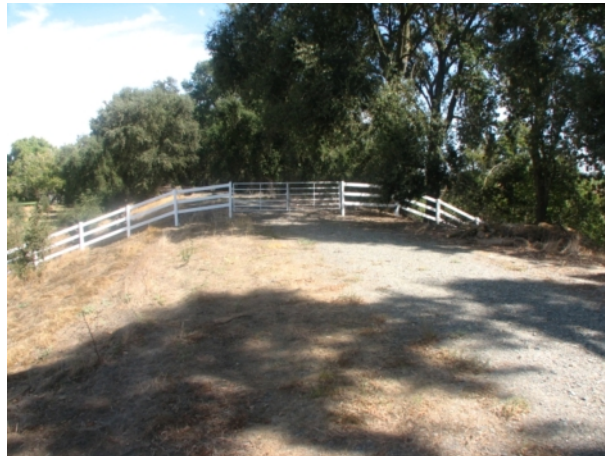
Levee Mile Report Line	71
Start Levee Mile	8.81
End Levee Mile	8.81
Location	Crown
Category	Earthen Levee
Item	Encroachments
New unauthorized fence and gate that extend from landside toe across levee crown to waterside toe.	
richard_20091216_164.jpg
